TITLE: Annual Rehabilitation Report & Forward Program 2023

SITE: Delta Coal

DELTA COAL
CHAIN VALLEY COLLIERY:
REHABILITATION WALKOVER
INSPECTION 2023

29 August 2023

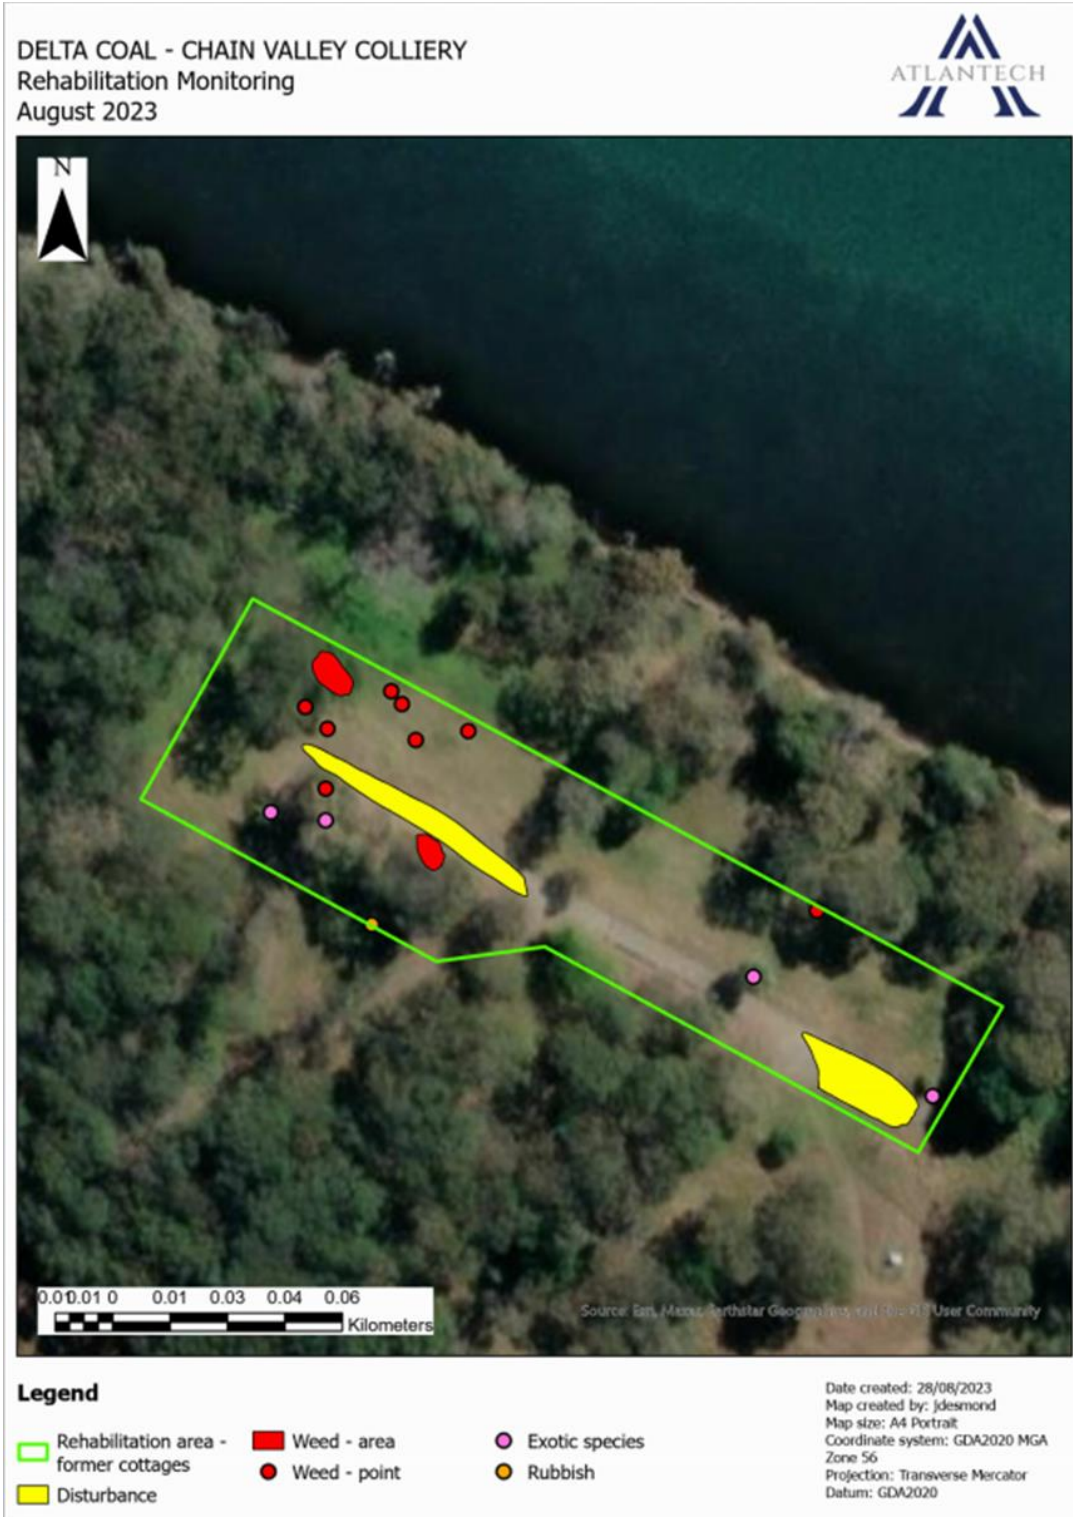
Figure 3: CVC mine cottages rehabilitation area findings (August 2023).

Rehabilitation success	High species diversity observed. A high abundance of casuarina saplings and several melaleuca, acacia and eucalyptus species recorded throughout the area. Several native eucalypt species greater than 10m in height were observed to be in seeding and recruitment stage.	Continue monitoring. Given natural regeneration of tree species, consider amendment of the final land use from open grassland to the surrounding native communities (Coastal Swamp Sclerophyll Forest).	
Other management items	One cultural heritage site fenced within the rehabilitation area. Some rubbish (i.e. chip packet and electrical cable) removed at the time of inspection. Remnant infrastructure was also recorded in the area including four star pickets forming a 0.5m ² square. Several species of bird observed including rainbow lorikeets and kookaburras. Wallaby scats were also found throughout the area but no impact from predation observed.	Nil.

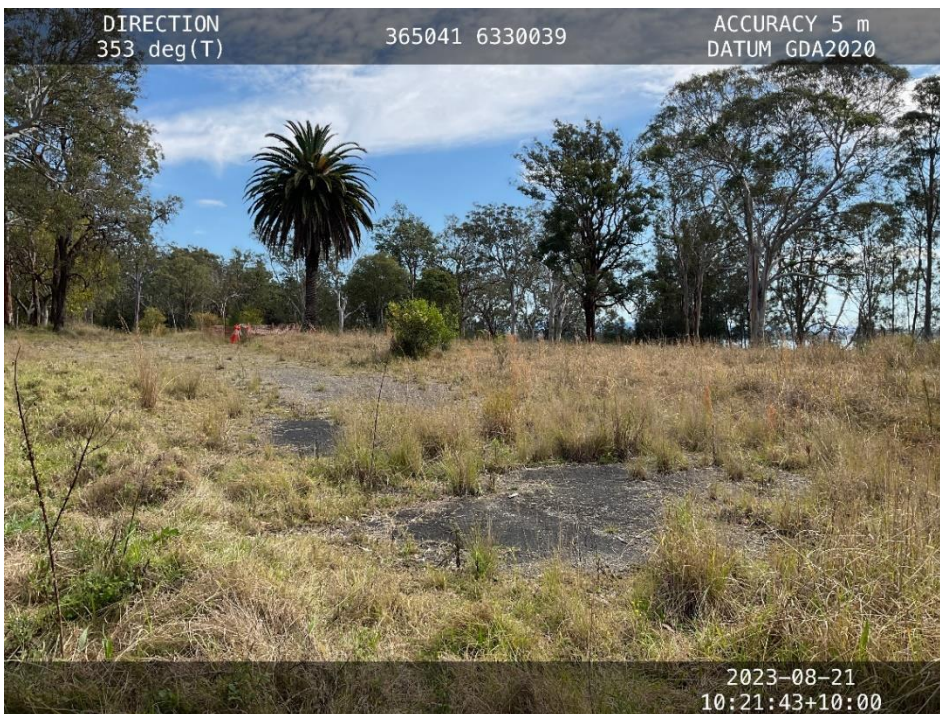
Plate 5: Sealed vehicle access track.

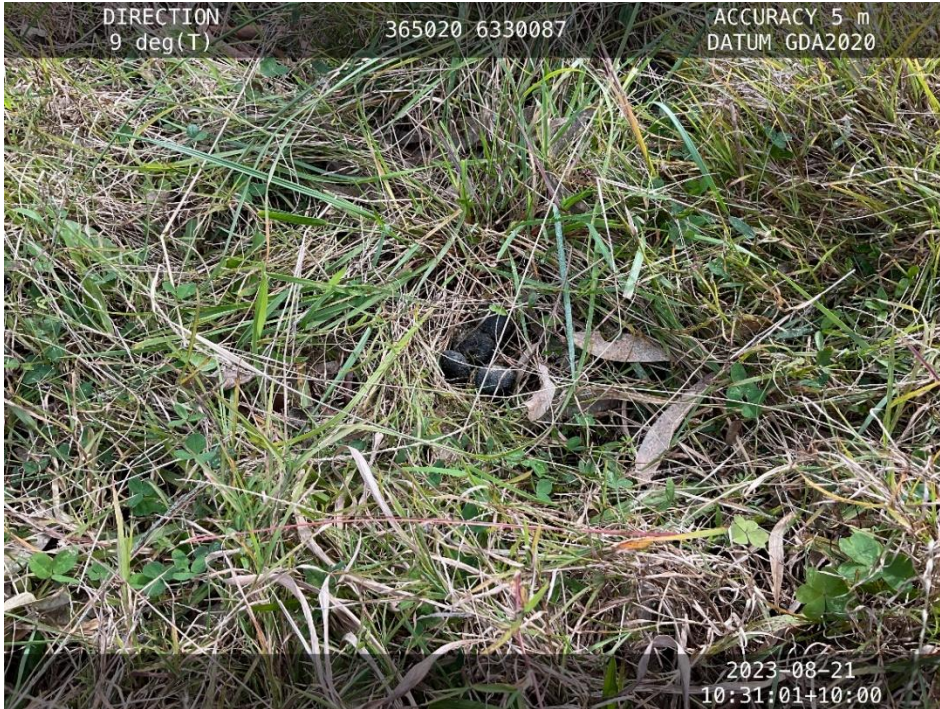
- Several species of bird observed including rainbow lorikeets and kookaburras. Wallaby scats were also found throughout the area but no impact from predation observed.

Plate 6: Wallaby scats found in the rehabilitation area.

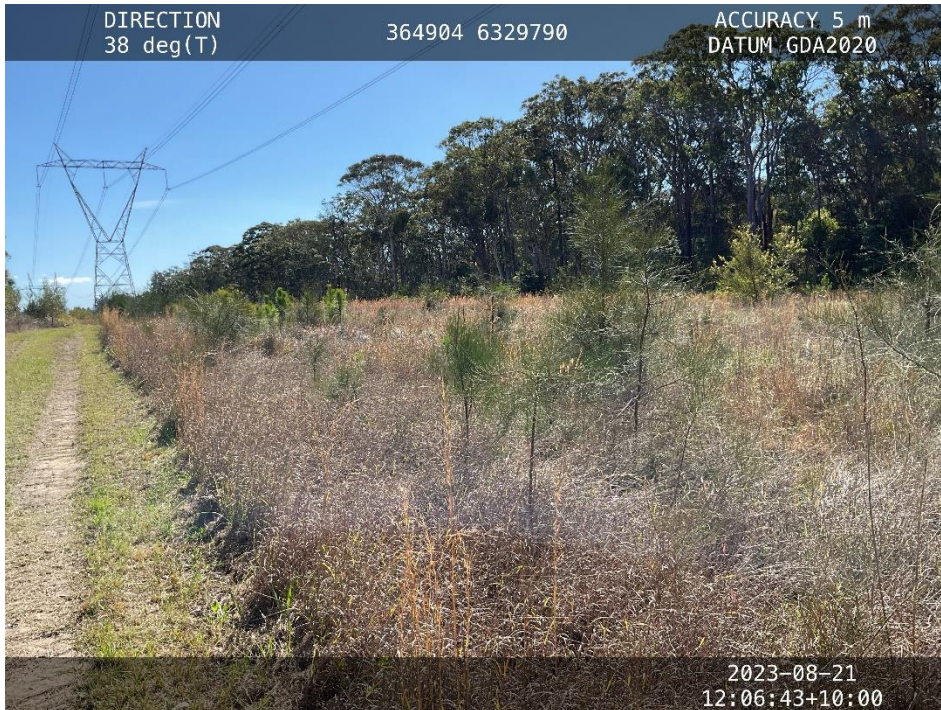
Plate 7: Analogue site photo point 1. Note ongoing disturbance as located within powerline easement.
