**Delta Coal
Manning & CVC Collieries**

**Seagrass Survey of Chain Valley Bay, Summerland
Point, Bardens Bay and Crangan Bay, Lake
Macquarie, NSW**

May 2020

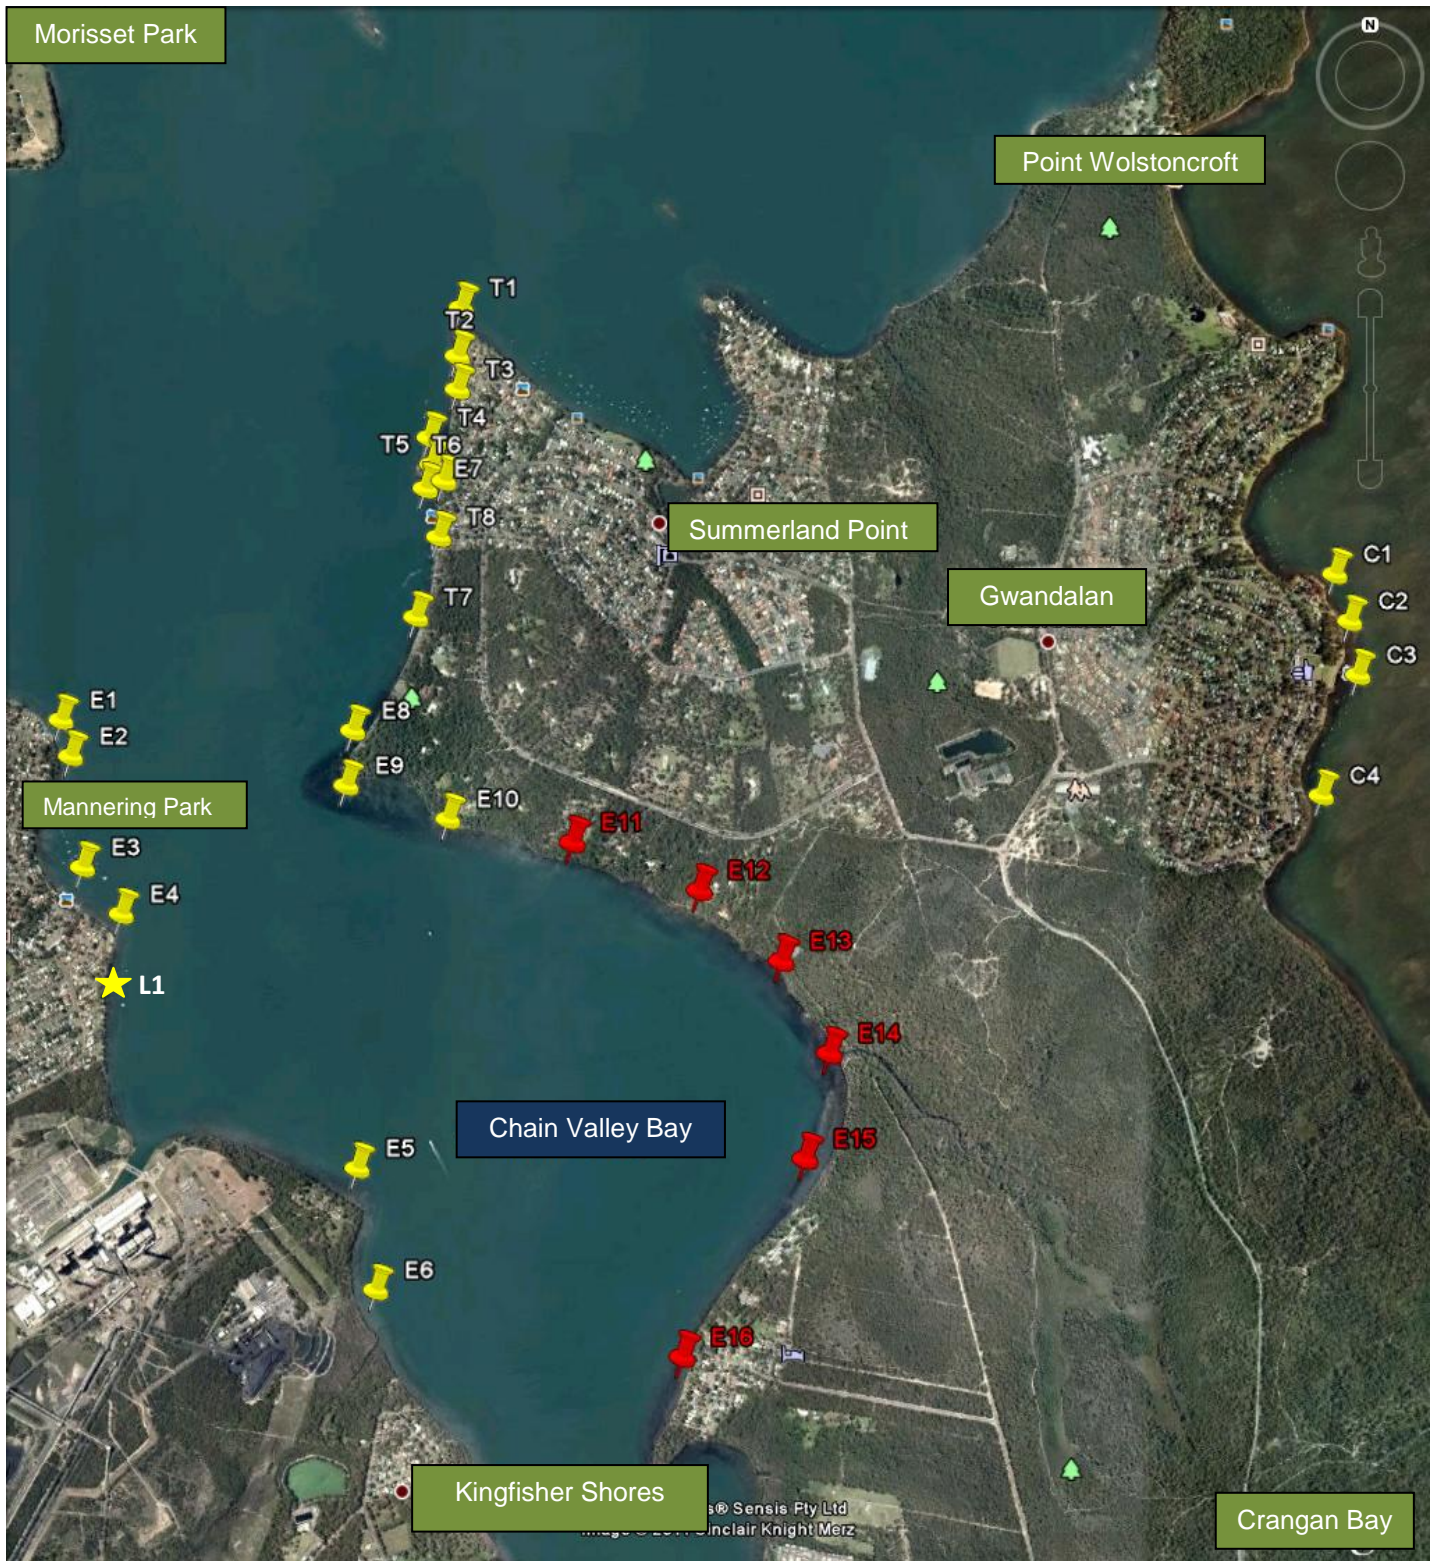
Figure 4.1 Locations of Transects in Chain Valley Bay, Summerland Point and Crangan Bay, Lake Macquarie.

- Transects E1 to E16 are established experimental transects in Chain Valley Bay and Summerland Point (**Figure 4.1**).

- Transects T1 to T8 are established experimental transects along Summerland Point (**Figure 4.1**).
- Transects C1 to C4 are established control stations in Crangan Bay (**Figure 4.1**).
- Transect L1 was established in Chain Valley Bay in 2015 (**Figure 4.1**).
- Transects A1 to A6 are established experimental stations in Bardens Bay. They were first surveyed in 2014 (**Figure 4.2**).
- Transects C5 to C6 were established in 2018 (**Figure 4.3**).
- Transects F1 to F7 were established in 2018 (**Figure 4.3**), and
- Transects S1 to S6 were established in 2018 (**Figure 4.3**).

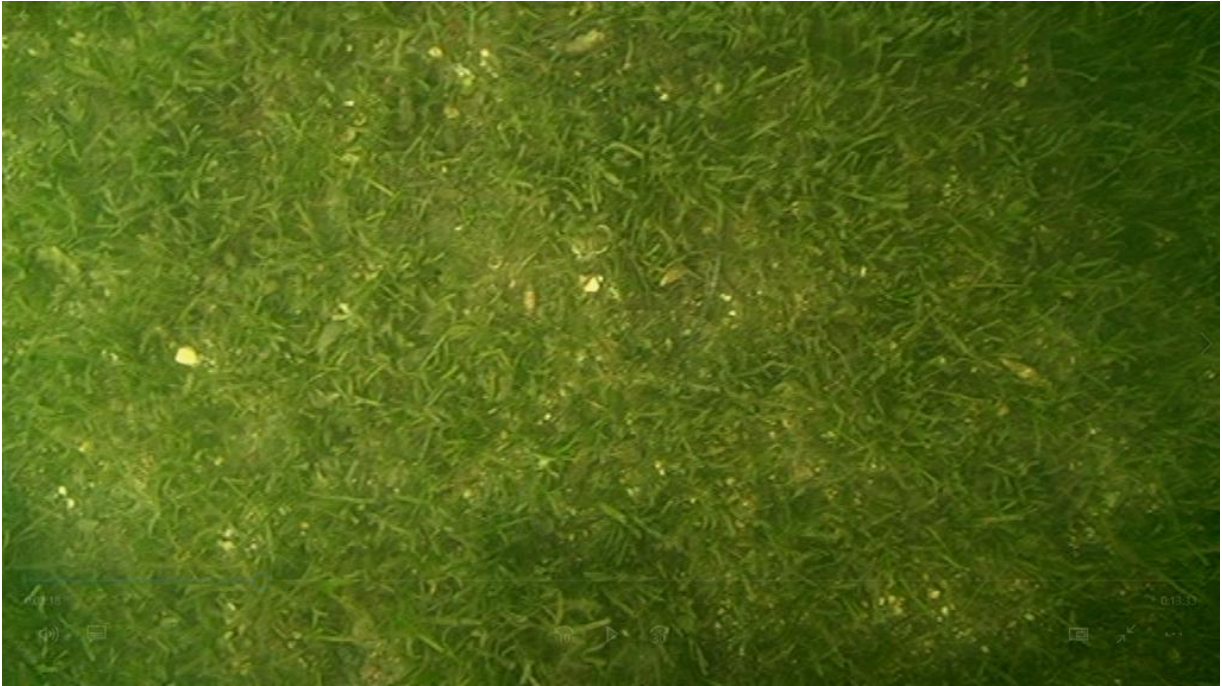
Plate 8.1 Short leaved sea grass with level 1 fouling (no fouling).

The following plates show the various growth characteristics of the seagrass *Zostera capricorni* in regards to leaf length. In the study area, due to environmental factors, *Zostera capricorni* either had short leaf growth (**Plate 8.1**) or was long leaved (**Plate 8.4**). The plates also show the levels of fouling of seagrass beds by filamentous algae and other algal species. In this study, fouling is described as No (Level 1), Low (Level 2) or Heavy (Level 3) (**Plates 8.2, 8.3, 8.5**).

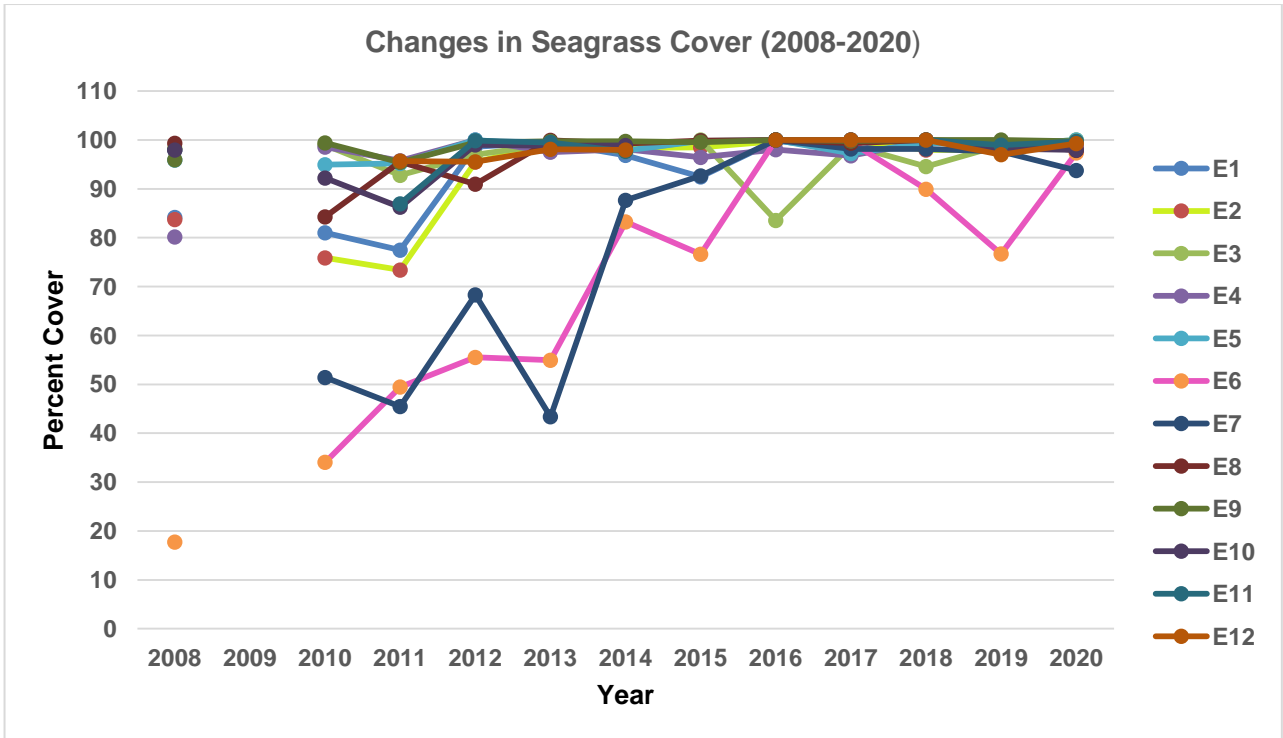
Figure 9.1 Changes in percent cover of seagrass at Transects E1 to E12

Figures 9.1 and **9.2** show changes in the percentage cover of seagrass at Transects E1 to E12 and T1 to T8 respectively over a period of 13 years. In June 2019, seagrass cover at the transects ranged from 24.7 percent to 100 percent in the study area (**Table 9.1, Figures 9.1 and 9.2**). By May 2020, seagrass cover ranged from 75.9 percent to 100 percent (**Table 9.1**). In addition, the health and condition of the seagrass was good, with moderate algal fouling observed in some quadrats at twelve of the fifty transects, namely E5, E15, E16, T1, T3, A4, A6, C1, C3, F1, F2 and F3 (**Appendix 1**).

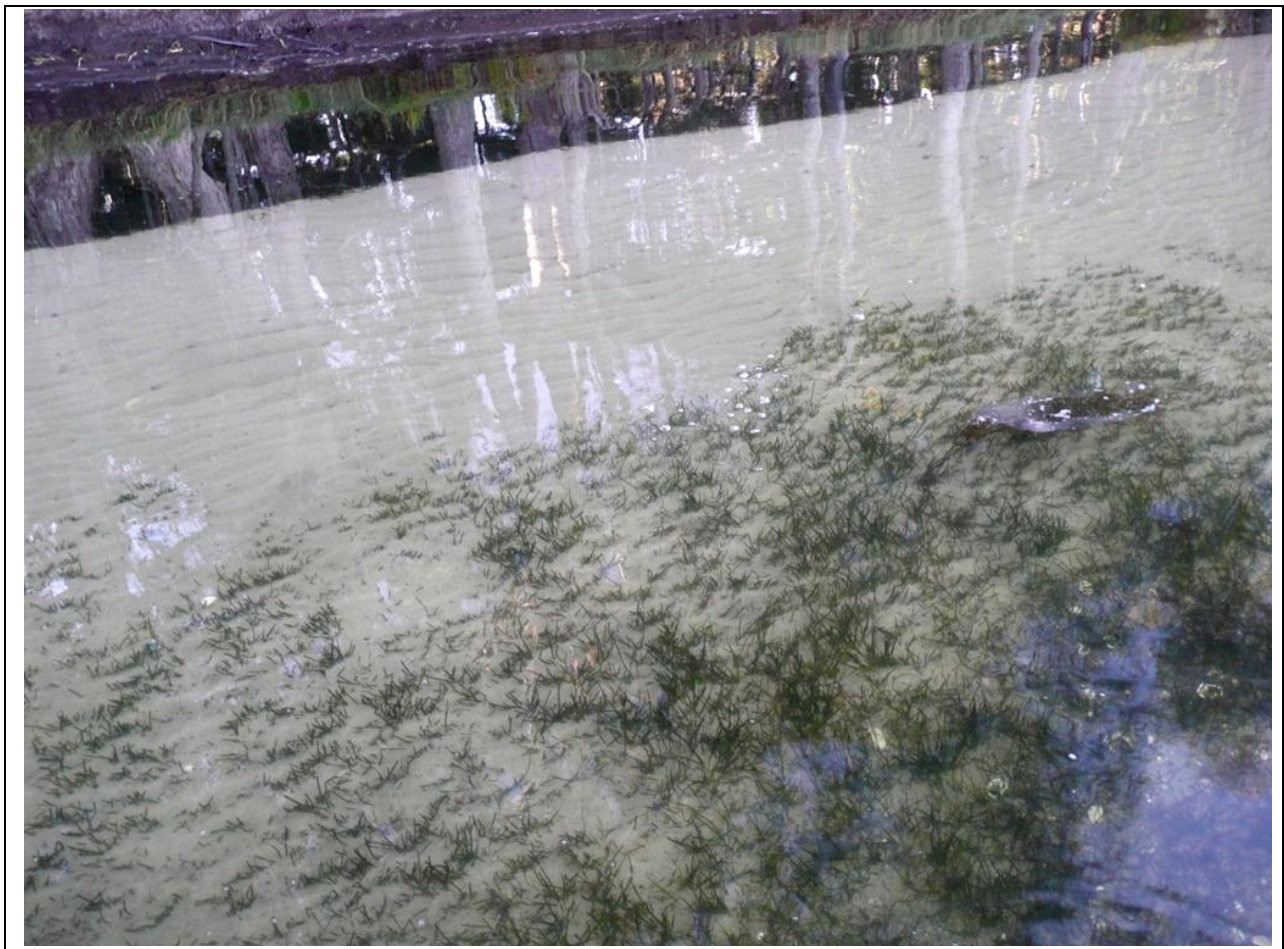
Plate 9.1 shows sand deposited on seagrasses along Summerland Point after strong onshore winds in June 2011. This event demonstrated how climatic conditions can effect seagrass coverage. It also shows how the movement of sand from deeper waters due to strong winds can increase water depth in some areas whilst decreasing water depth closer to shore as sediment is deposited.

Plate 9.1 *Zostera capricorni* covered by sand along Summerland Point after strong southwesterly winds in 2011.

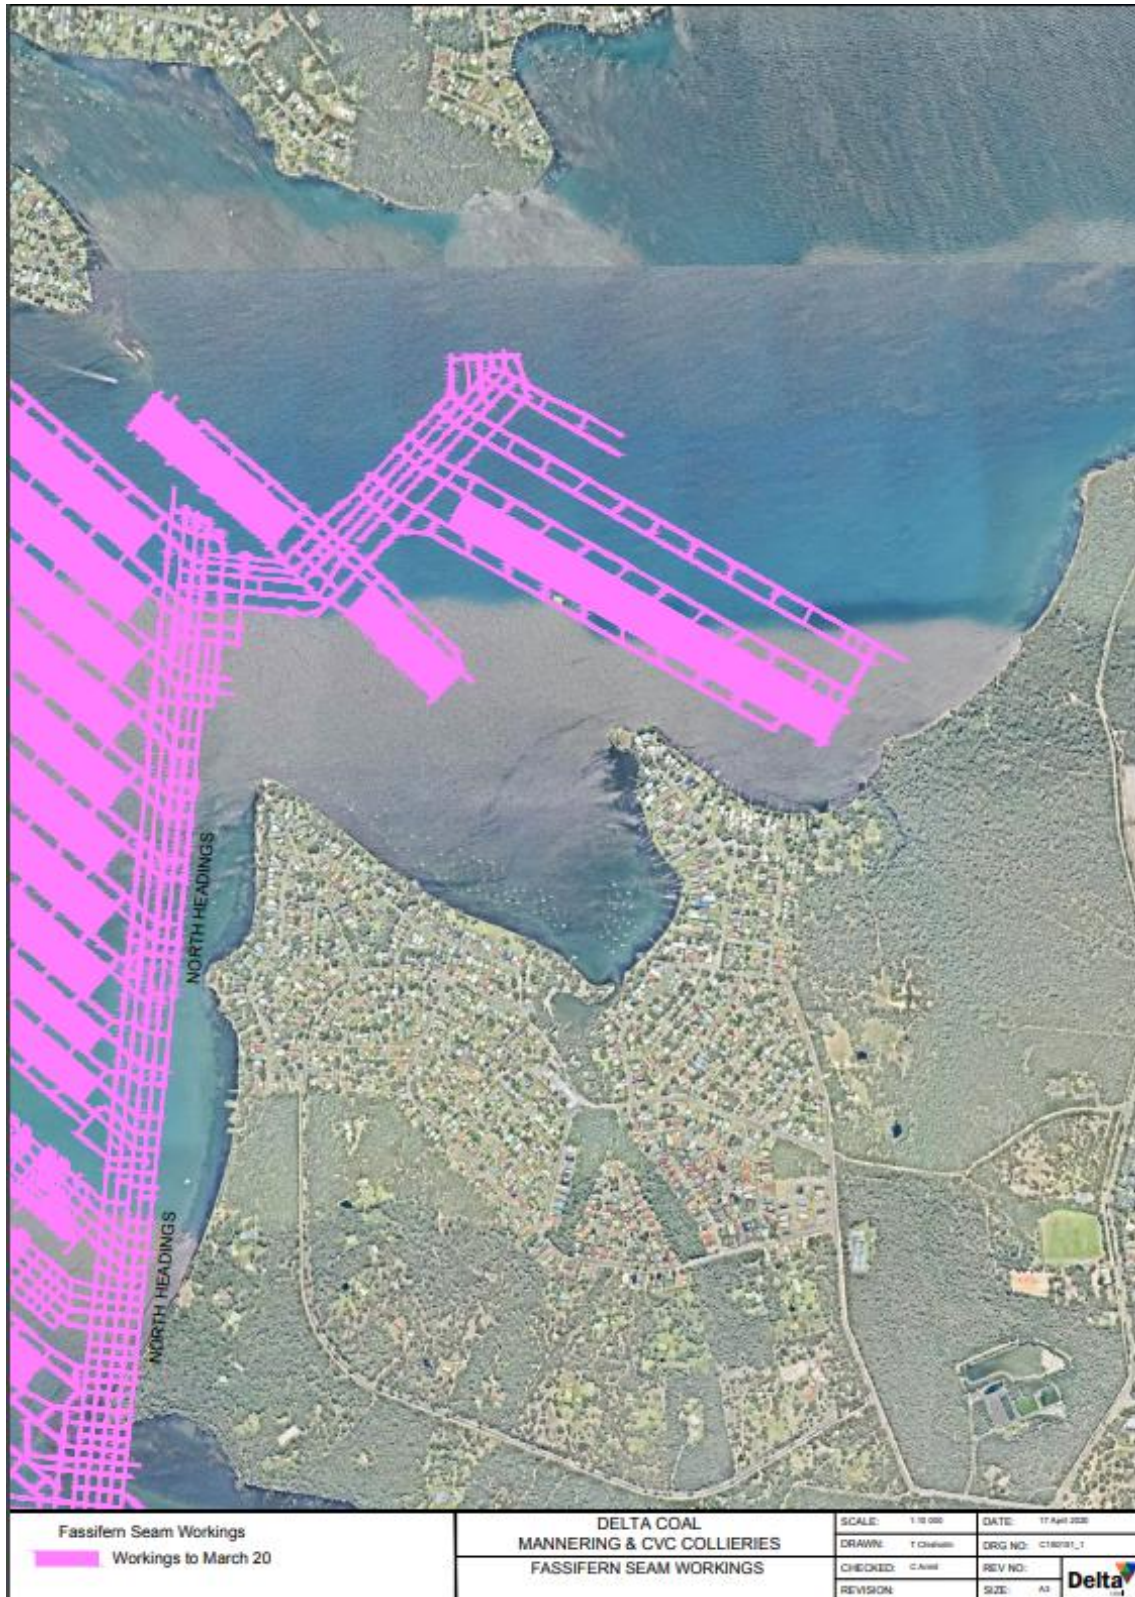
Figure 10.1 Extent of Fassifern seam workings to March 2020.

Figure 10.1 shows the extent of mining up to March 2020.
